Manhole Inspection Summary

Manhole # **S19G__036MH**

Insp Date: **10/8/07 11:05 AM**

Location Address: **2148 SMALLWOOD ST**

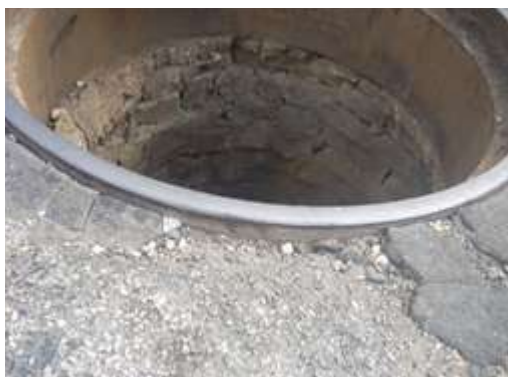
Defect 1

Cover Shape: **Circular** Diameter: **24** (in.) Length: (in.) Dist A/B Grade: **0.5** (in.)

GRADE ADJUSTMENT

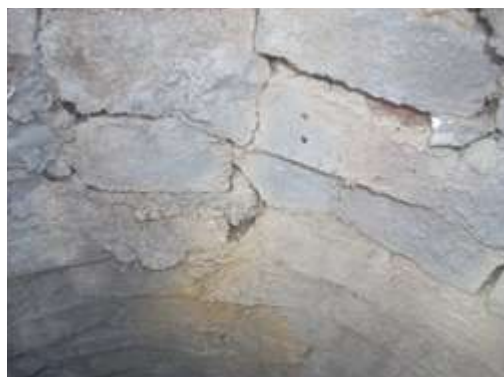
Defect 6

Condition: ☐ Sound ☐ Cracked ☐ Root Intrusion ☐ Loose Brick ☒ **Deteriorated**

DETERIORATED CORBEL

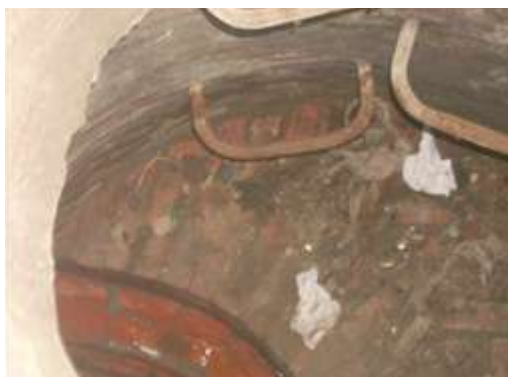
Defect 5

Steps Count: **5** Missing: **0** ☒ **Corroded**

CORRODED STEPS

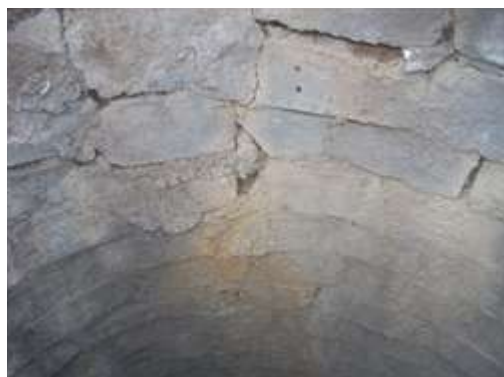
Defect 4

Infiltration: ☐ None ☒ **Joint** ☐ Cracks ☐ Mortar ☐ Roots ☐ Wall

INFILTRATION EVIDENCE, CORBEL
JOINT

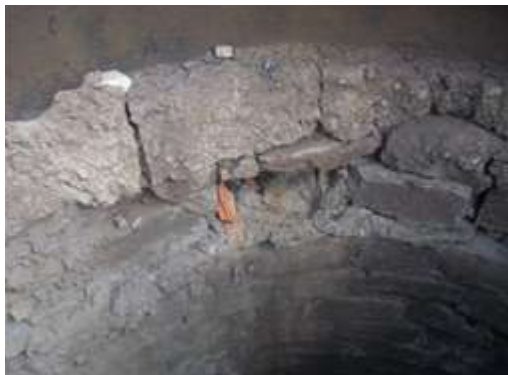
Defect 3

Condition: ☐ Sound ☐ Cracked ☐ Root Intrusion ☐ Loose Brick ☒ **Deteriorated**

DETERIORATED CHIMNEY

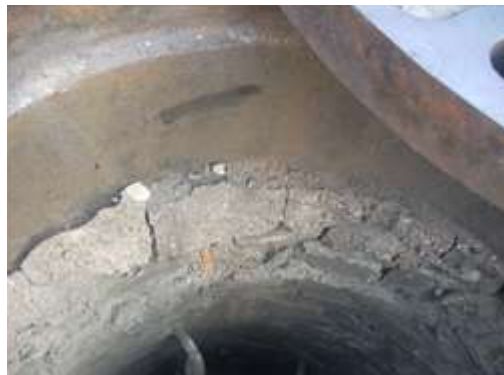
Defect 2

Frame Offset: **3** (in.) Condition: ☒ Sound ☐ Cracked ☐ Leaks

FRAME OFFSET

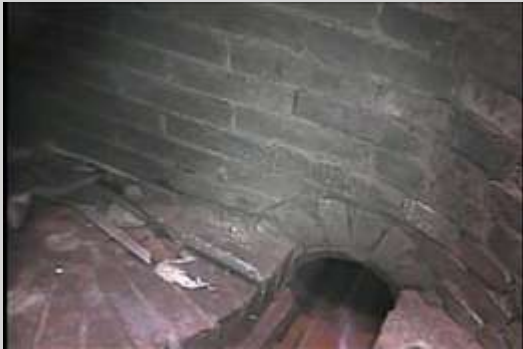
12 O'Clock Outflow

8 in. Circular Gravity Sewer
Pipe Out @ 12 O'Clock

Pipe Height: **8.4** (in.) Rod and Bar (Angled)
Pipe Material: **Clay** ☐ Pipe Lined
Invert Depth: **9.99** (ft.) Flow Characteristics: **Fast**
Deposits: ☒ None ☐ Mud ☐ Sludge ☐ Debris ☐ Grease
Silt Depth: (in.) Deposits Extent:
Infiltration: **None** Pipe Seal Cond: **Sound**

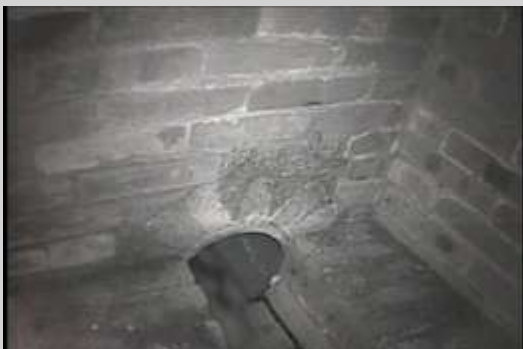
7 O'Clock Inflow

8 in. Circular Gravity Sewer
Pipe In @ 6 O'Clock

Pipe Height: **7.2** (in.) Rod and Bar (Angled)
Pipe Material: **Clay** ☐ Pipe Lined
Invert Depth: **9.57** (ft.) Flow Characteristics: **Slow**
Deposits: ☒ None ☐ Mud ☐ Sludge ☐ Debris ☐ Grease
Silt Depth: (in.) Deposits Extent:
Infiltration: **None** Pipe Seal Cond: **Sound**
